**Flood Control Project Maintenance
Levee Inspections**

Maintenance Issue Types Only, Levee Inspection Report By Mile - Fall 2019

Reclamation District No. 2091 Chase

Waterway	Bank	Unit Miles	Inspection Start/End	Inspector
Unit No. 01 San Joaquin River	Right	7.46	11/05/2019 11/05/2019	Corey Fujitani

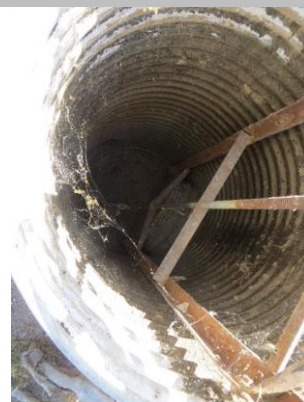
Photo 2 of 3 : UCIP_FA_2019_43207_38147.jpg

Slide gate in 36-inch CMP riser on WS toe.

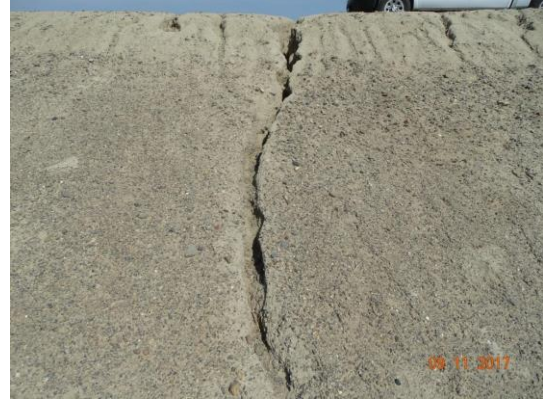
Photo 1 of 2 : FA_2019_RD2091_318_16_20190912_00015.jpg

LM Start	0.25	Rating **	A/W	Issue No.	16
LM End	0.28	Issue Type +	Ma	Location *	LS
Category	Earthen Levee			GPS Latitude/Longitude	
				Start	End
Item	Erosion / Bank Caving			37.541492 °	37.541408 °
				-121.097052 °	-121.097453 °
DWR ID	DWR_RD2091_01_s_2016_16				
Comment Code					
E1 : Note and monitor erosion site.					
Inspector Comment					
Several sites of rill erosion and possible rodent holes along landward shoulder and slope.

Looking northwest at rill erosion on landside slope.

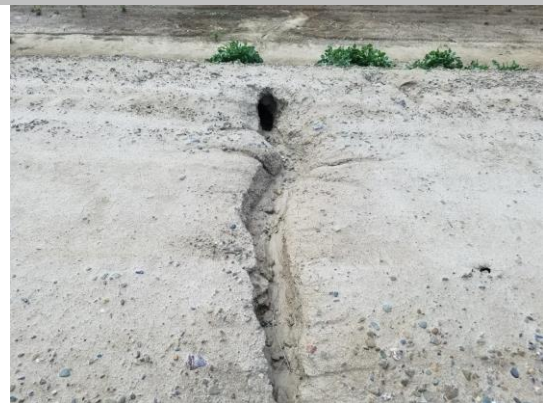
Photo 2 of 2 : FA_2019_RD2091_318_16_20190912_00016.jpg

Looking east at rill erosion above rodent hole on landward slope. (Spring 2017)

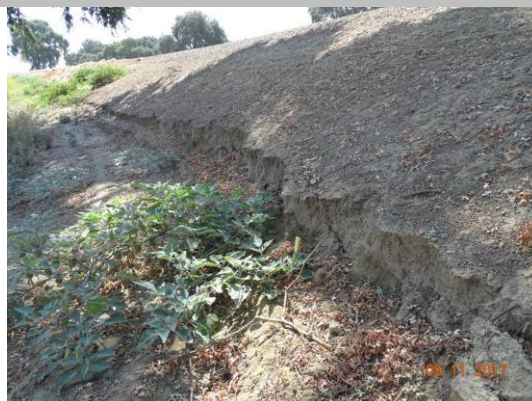
Photo 1 of 1 : FA_2019_RD2091_318_18_20190912_00017.jpg

LM Start	2.05	Rating **	M	Issue No.	18
LM End	2.06	Issue Type +	Ma	Location *	LS
Category	Earthen Levee			GPS Latitude/Longitude	
				Start	End
Item	Erosion / Bank Caving			37.526083 °	37.525897 °
				-121.099328 °	-121.099116 °
DWR ID	DWR_RD2091_01_f_2017_18				
Comment Code					
E2 : Schedule repair of erosion site prior to the next inspection.					
Inspector Comment					
Erosion at the landside toe.

Looking southeast at erosion on the toe of the landside slope.

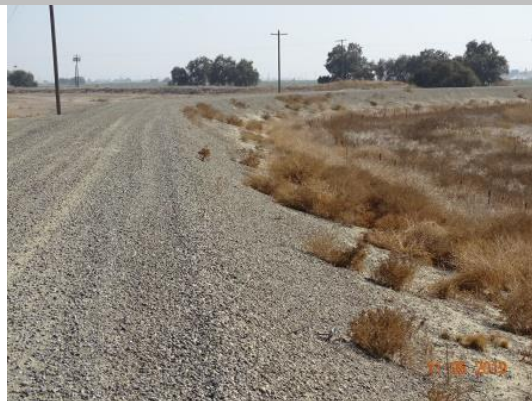
Photo 1 of 1 : FA_2019_RD2091_318_17_20191114_00045.jpg

LM Start	7.27	Rating **	M	Issue No.	17
LM End	7.39	Issue Type +	Ma	Location *	WS
Category	Earthen Levee			GPS Latitude/Longitude	
				Start	End
Item	Vegetation			37.480994 °	37.479774 °
				-121.046195 °	-121.044869 °
DWR ID	DWR_RD2091_01_f_2019_17				
Comment Code					
V1 : Control annual grass and weeds on the levee slopes and easements.					
Inspector Comment

View of the waterside slope looking upstream. (Fall 2019)

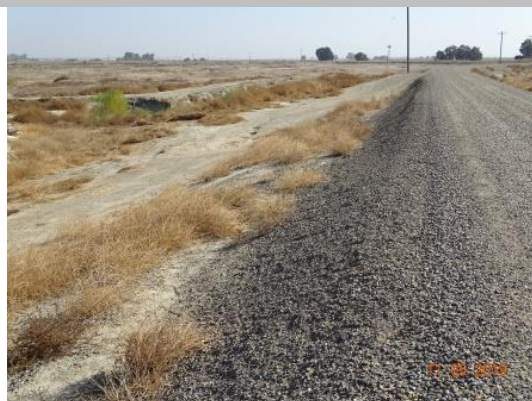
Photo 1 of 1 : FA_2019_RD2091_318_19_20191114_00046.jpg

LM Start	7.28	Rating **	M	Issue No.	19
LM End	7.30	Issue Type +	Ma	Location *	LS
Category	Earthen Levee			GPS Latitude/Longitude	
				Start	End
Item	Vegetation			37.480992 °	37.480799 °
				-121.046190 °	-121.045876 °
DWR ID	DWR_RD2091_01_f_2019_19				
Comment Code					
V1 : Control annual grass and weeds on the levee slopes and easements.					
Inspector Comment

View of the landside slope looking upstream. (Fall 2019)

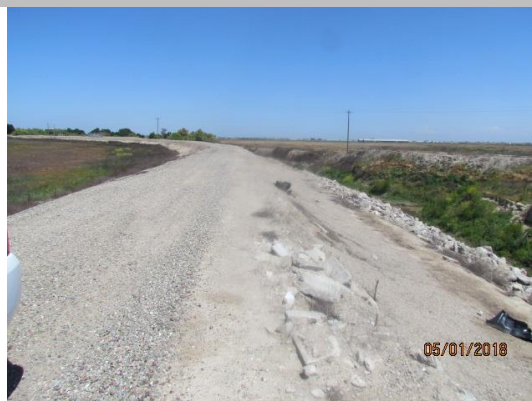
Photo 3 of 3 : FA_2019_RD2091_318_8_20190912_00003.jpg

LM Start	7.42	Rating **	U	Issue No.	8 (cont)	
LM End	7.45	Issue Type +	Ma	Location *	LS	
Category	Earthen Levee			GPS Latitude/Longitude		
				Start		End
Item	Erosion / Bank Caving			37.479308 °	37.478998 °	
				-121.044708 °	-121.044660 °	
DWR ID	DWR_RD2091_01_s_2017_8					
Comment Code						
E2 : Schedule repair of erosion site prior to the next inspection.						
Inspector Comment						
Repaired area with concrete containing rebar. Need to remove rebar.

Looking east at repaired site on waterward slope and toe. (Spring 2018)

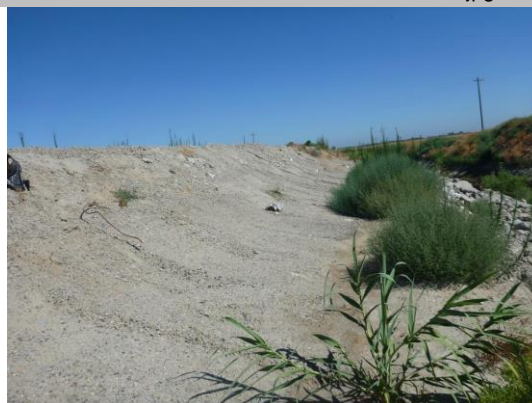
Photo 1 of 3 : LEVAL_FA_2019_473_2326.jpg

LM Start	7.45	Rating **	A/W	Issue No.	23	
LM End	7.45	Issue Type +	Ma	Location *		
Category	Supplemental			GPS Latitude/Longitude		
				Start	End	
Item	2017 Storm Damage			37.479000 °	37.479000 °	
				-121.044000 °	-121.040000 °	
DWR ID	LMA-300					
Comment Code						
Inspector Comment						
Levee Evaluation Comments						
Description:Sloughing at Mile 7.59 of the San Joaquin River						
Site ID No:473						
Site Designation:LMA-300						
Repair Type: Erosion						
Rating:Area of Concern						
Field Date:7/20/2017						
Notes: Concrete rubble was installed here during the storms after noticing cracks and sloughing. It has rebar sticking out and needs to be replaced with clean rip rap. Responsibility is grey here because TID maintains channel and placed concrete during storm.
